Service Bulletin No. 102-26-3

SGS 1-26, A, B, C

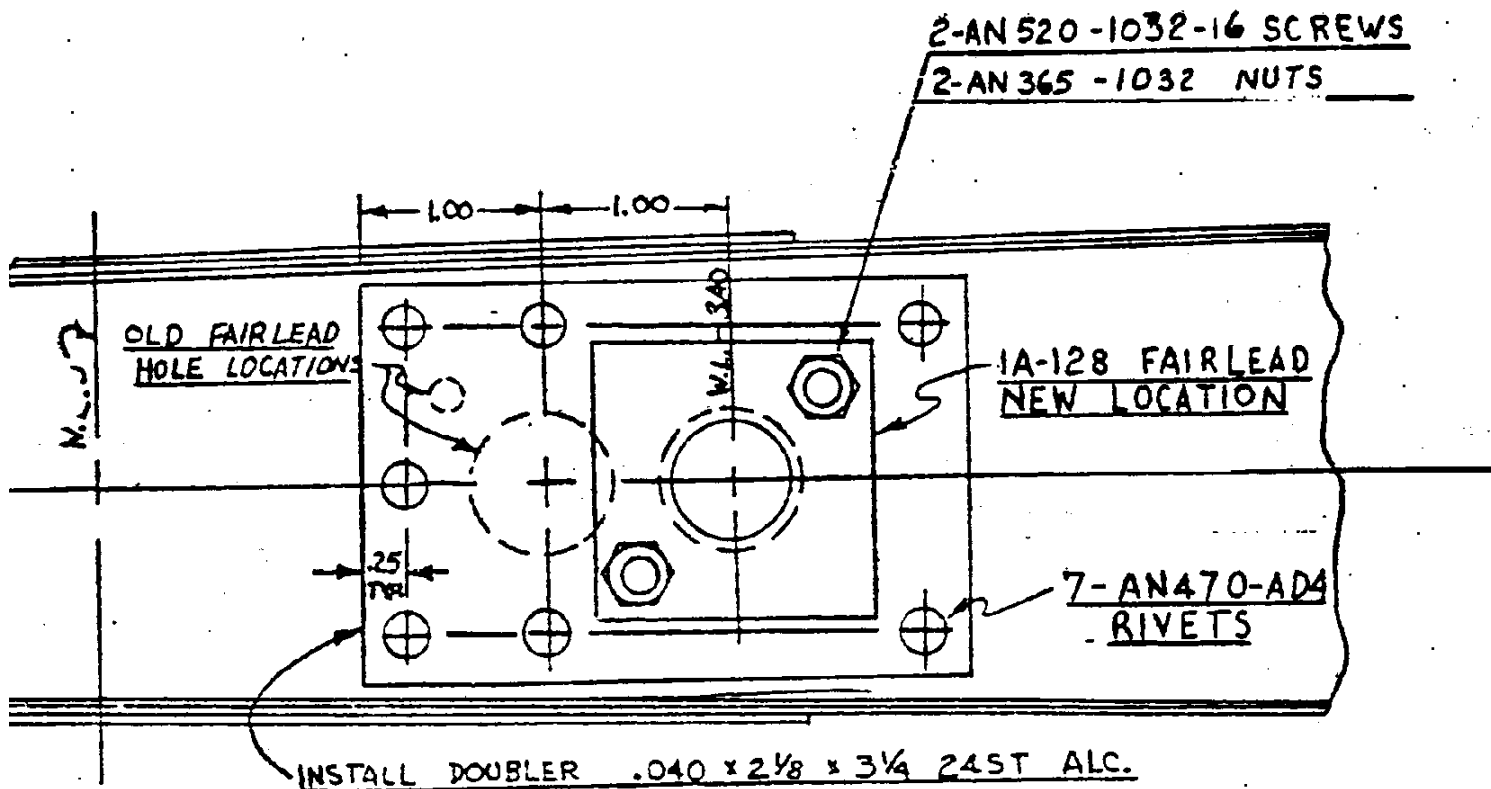
A condition has been discovered which could cause excessive wear on the 26B120-2A Elevator Control Cable at the 1A-128 Fairlead on the Fin Spar. This wear would be induced by the location of the 1A-128 Fairlead at W.L.--2.40. This condition exists on all ships to and including Ship No. 75.

The condition noted may be eliminated by relocation of the 1A-128 Fairlead to W.L. 3.40 according to the attached sketch. Material kits for this work are available upon request.

We recommend the accomplishment of this relocation at the earliest convenience and thorough inspection of the area and parts for indications of wear, each 25 hours until the relocation is made.
