Schweizer Aircraft Corporation
Elmira, New York

SERVICE BULLETIN NO. 102-26-4

SGS 1-26 SEAT BACK

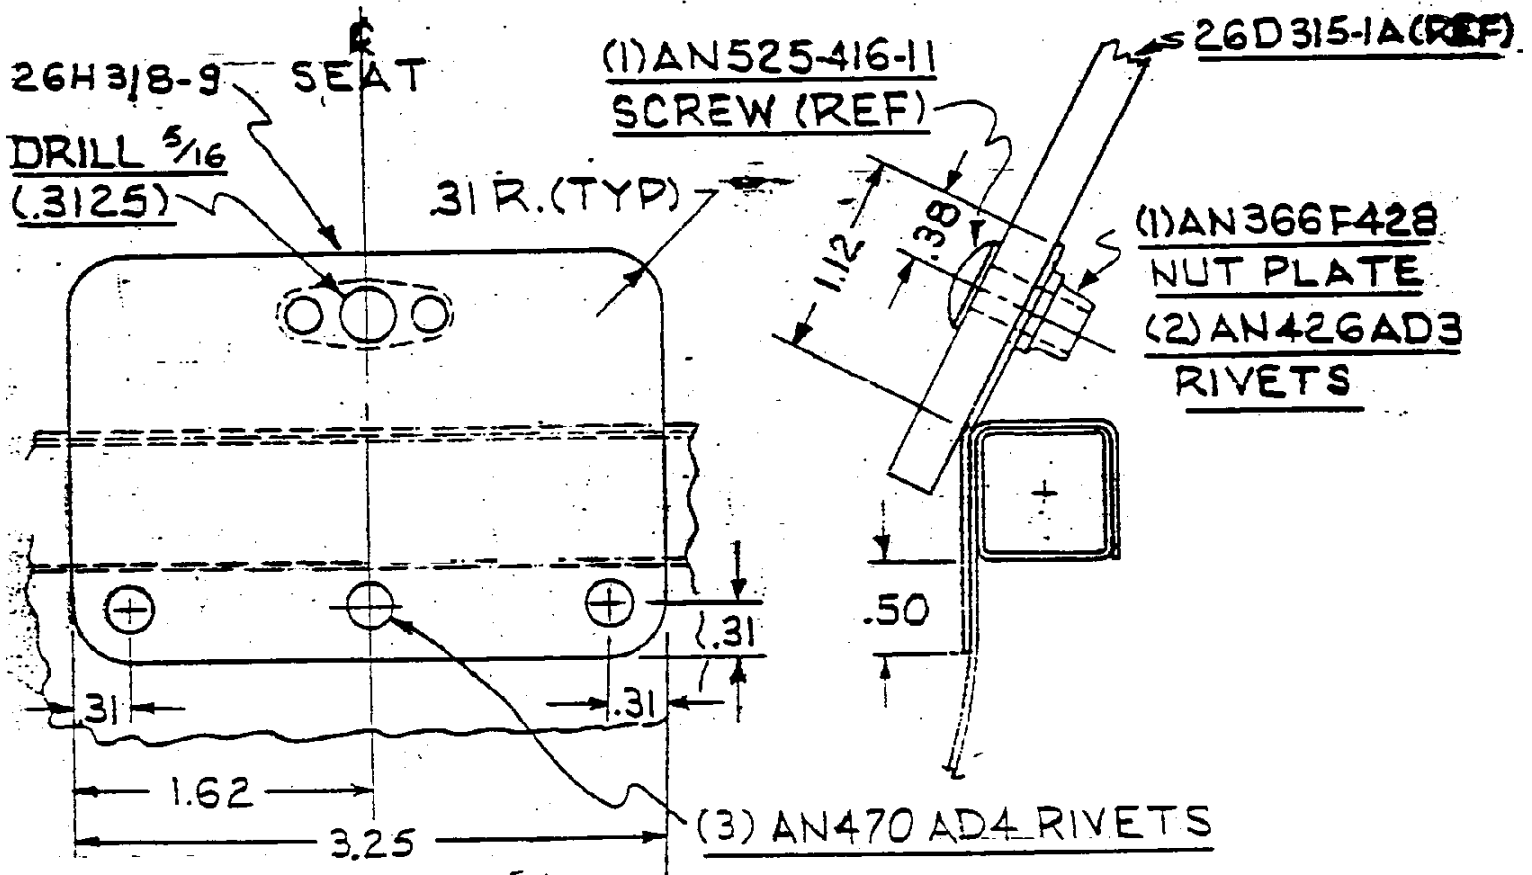
There have been cases reported where the seat back, which is held at the bottom end by aluminum clips, has disengaged and moved back suddenly. This is disconcerting to the pilot and could cause loss of control at a critical flight condition.

1. TO PROVIDE ADDITIONAL ATTACHMENT
FOR SEAT BACK.

It is recommended that as a routine preflight check that this seat back be checked to see that it is secure in its normal position. If the clips, 26D-315-4 are distorted, they should be reworked or replaced. If they are reworked, check carefully for cracks. An alternate design is being investigated and you will be advised if this becomes available.

CHANGE: ^{REV ES 9/10/62} 1. ADD ATTACH. PLATE TO SEAT AS SHN.
MAKE FROM .040 2024-T3 ALC
