Schweizer Aircraft Corp.
Post Office Box 147
Elmira, New York 14902

Bulletin No. SA-006
Date: 1 March 1989
Page 1 of 1

SUBJECT: Replacement of Seat Back Adjustment Bracket

MODELS AFFECTED: All SGS 1-26D and SGS 1-26E

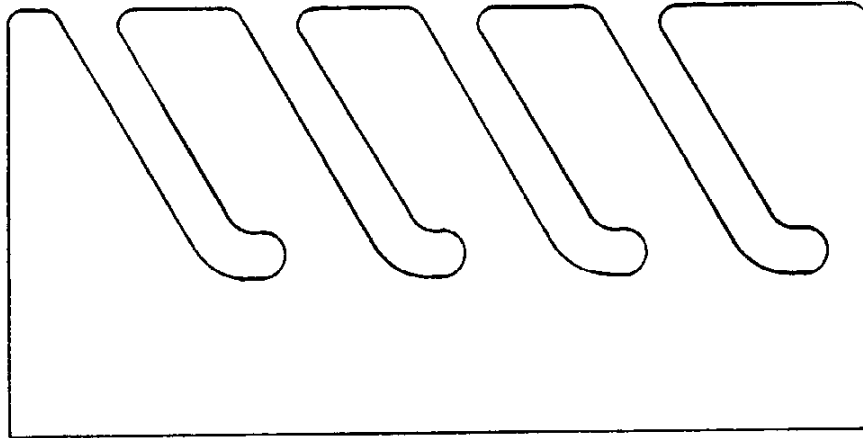
NEW DESIGN 26245D-3 BRACKET

A new bracket, (PN26245D-3), and spacer, (PN26245D-5), has been designed to resolve this problem. This service bulletin lists instructions to install this improved seat back adjustment bracket. This improved bracket should reduce the possibility of sudden seat back movement.

- Drill out rivets securing existing seat adjustment brackets. Remove brackets.
- Clean up bracket mount area removing any burrs and sharp edges.
- Paint bracket mount areas with a thin coat of Zinc Chromate or equivalent primer to prevent corrosion.
- Place the spacer between the inside fuselage wall and the lower edge of bracket.
- Mark the mount area and drill holes as per old bracket using a #30 drill bit and secure with Cleco.
- Install rivets (MS20426AD4) (5) places on each bracket and spacer kit.
- Paint exterior of rivet heads.
- Record compliance with this service bulletin in the aircraft log book.

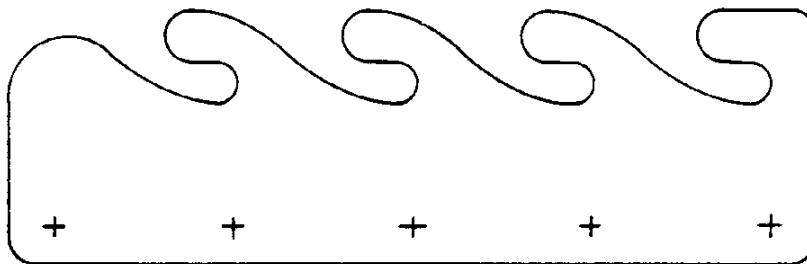
OLD DESIGN 26350D BRACKET

PREFACE: Reports indicate that on the affected aircraft, the pilot's seat back could inadvertently slide back during tow, when experiencing turbulence or during certain flight attitudes where a negative g condition may exist.
