An Oil Flow Study and Turbulator Installation on a Schweizer 1-26 Wing

By Richard H. Johnson- Printed in Soaring Magazine-May 1997.

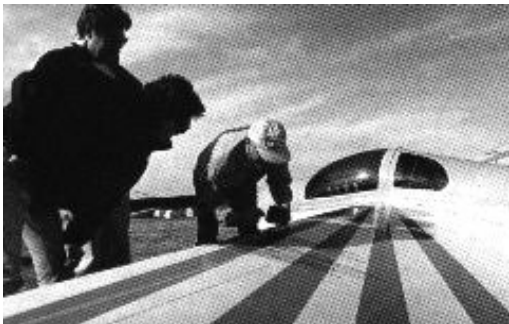
Photo 1. The author applying blackened 10-40 motor oil to the 1-26's wing top surface with a paint brush.

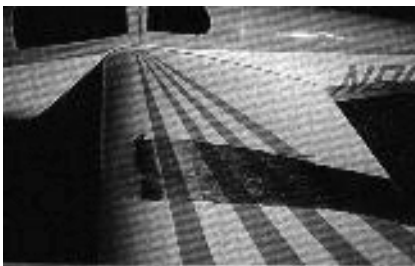
Photo 2. Oil flow pattern on wing top surface after 30 minute flight, with large laminar separation bubble shown by the wide black band near the leading edge.

Dan then flew S/N 182 in weak thermals for about 1/2 hour, and we then took the following 4 photos after he landed. **Photo 2** was taken of the left wing top surface about 5 feet out from the fuselage. It indicates that laminar flow existed back to about .124 chord, followed by a surprisingly large (about 2.5 inch wide) separation bubble, and normal turbulent flow behind that (indicated by the gradual thickening of the oil). The small break in the mid portion of the bubble is a turbulent flow wedge that was caused by a small piece of dirt or grass embedded in the oil near the leading edge. It was likely kicked up by the tow plane during takeoff.

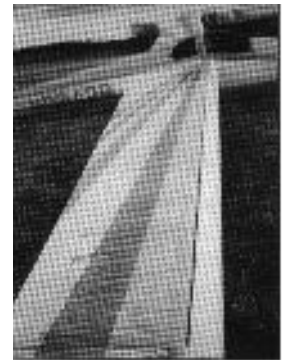
Photo 9. Oil flow pattern after flight with a full span black turbulator strip attached about 11% of chord aft of the leading edge. Note that the turbulator was successful in eliminating the high drag laminar separation bubble along the entire span, except for a small area, near the wing tip.

Photo 9 shows both the black turbulator strip on S/N 182's wing top surfaces, and the oil flow patterns after the first flight. Note that the flow patterns indicate that our turbulator was 100% successful in eliminating the unwanted separation bubble over the entire wingspan, except for the final 2.5 inches at the tip where I had omitted installing the turbulator because I had thought that it would not be needed there. I later extended the turbulator strip an additional 2 inches.
